E6086.01-113-11-R0
ACOUSTICAL PERFORMANCE TEST REPORT
ASTM E90

Series/Model: BD-325

Type: Side-Hinged Single Balcony Door System

Report No	E6086.01-113-11
Test Date	04/21/15
Report Date	05/08/15

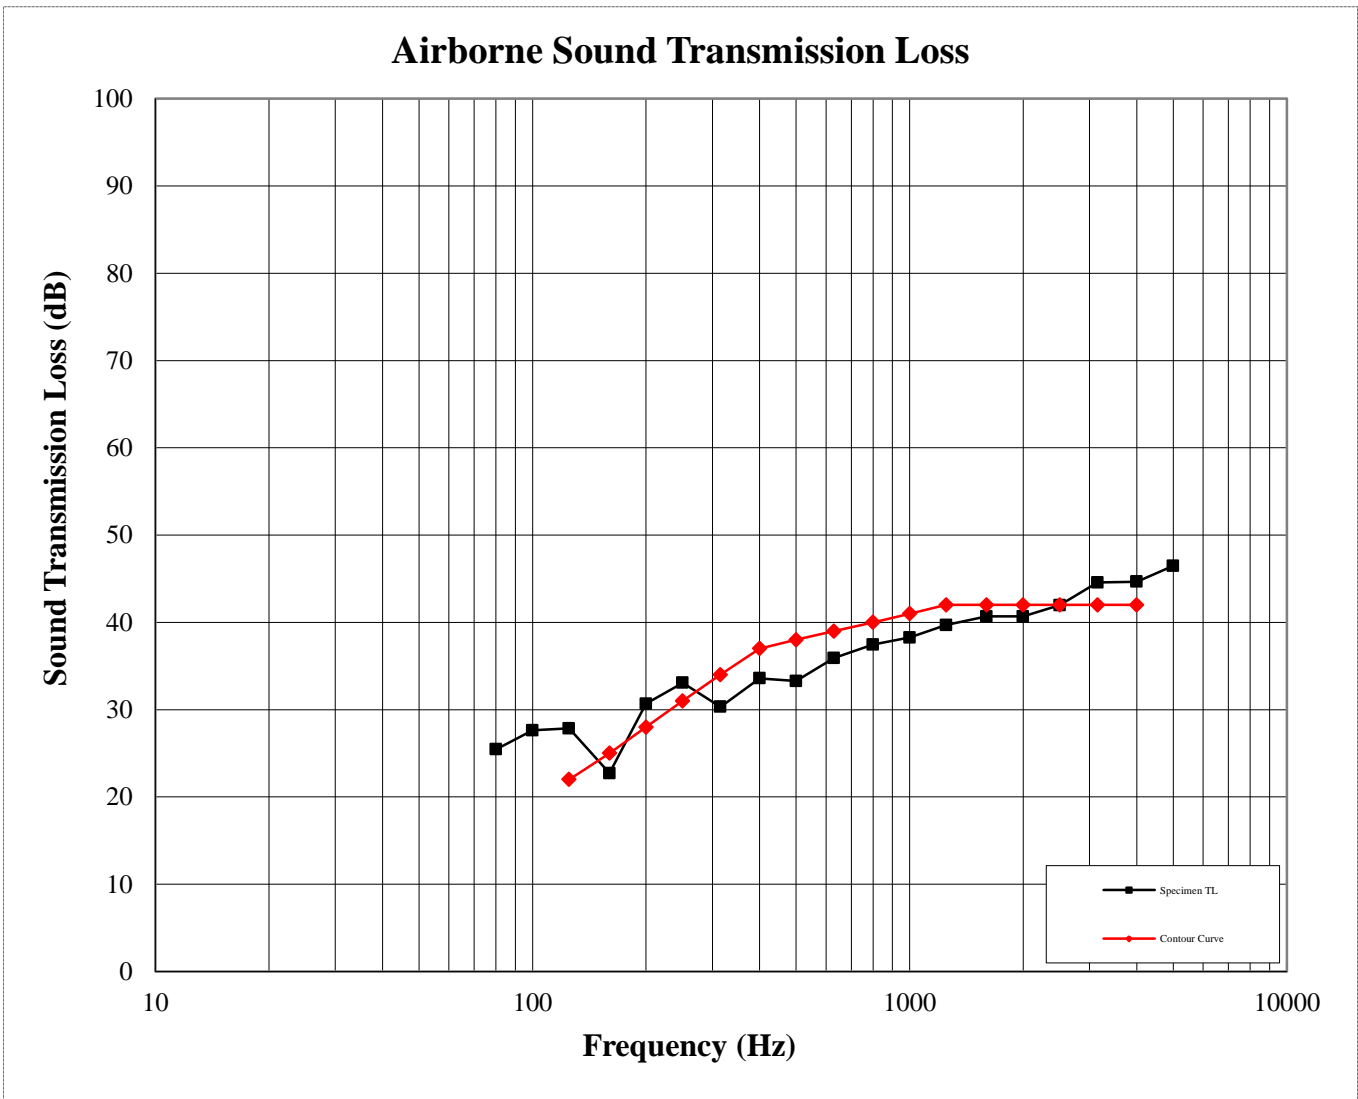
AIRBORNE SOUND TRANSMISSION LOSS
ASTM E 90

Test Date	04/21/15					
Data File No.	E6086.01A1					
Client	Gamco Corporation					
Description	Series/Model: BD-325, side-hinged single balcony door system with 1-1/4" IG (7/16" laminated exterior, 9/16" air space, 1/4" laminated interior), Glass temperature 75°F					
Specimen Area	2.01 m ²	Receive Temp.	22.4 °C		Source Temp.	22.5 °C
Technician	Daniel P. Platts	Receive Humidity	50%		Source Humidity	48%

STC Rating **38** *(Sound Transmission Class)*
Deficiencies **27** *(Sum of Deficiencies)*
OITC Rating **33** *(Outdoor-Indoor Transmission Class)*

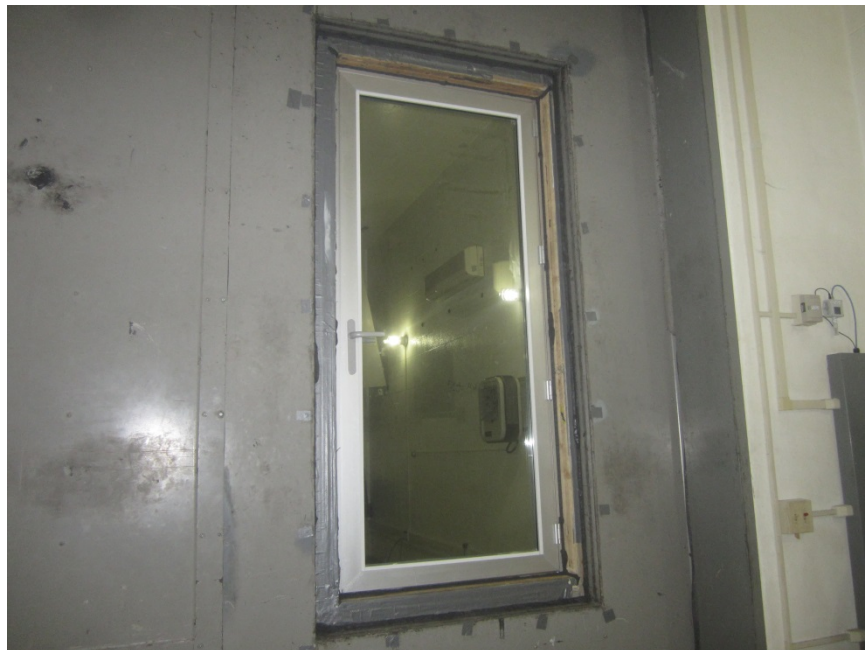
Source Room View of Installed Specimen
