# **GAMCO CORPORATION**

# **ACOUSTICAL PERFORMANCE TEST REPORT**

ASTM E90 SOUND TRANSMISSION LOSS TESTING ON A  
D350 SERIES, SIDE-HINGED DOUBLE DOOR SYSTEM

K4568.02-113-11-R0

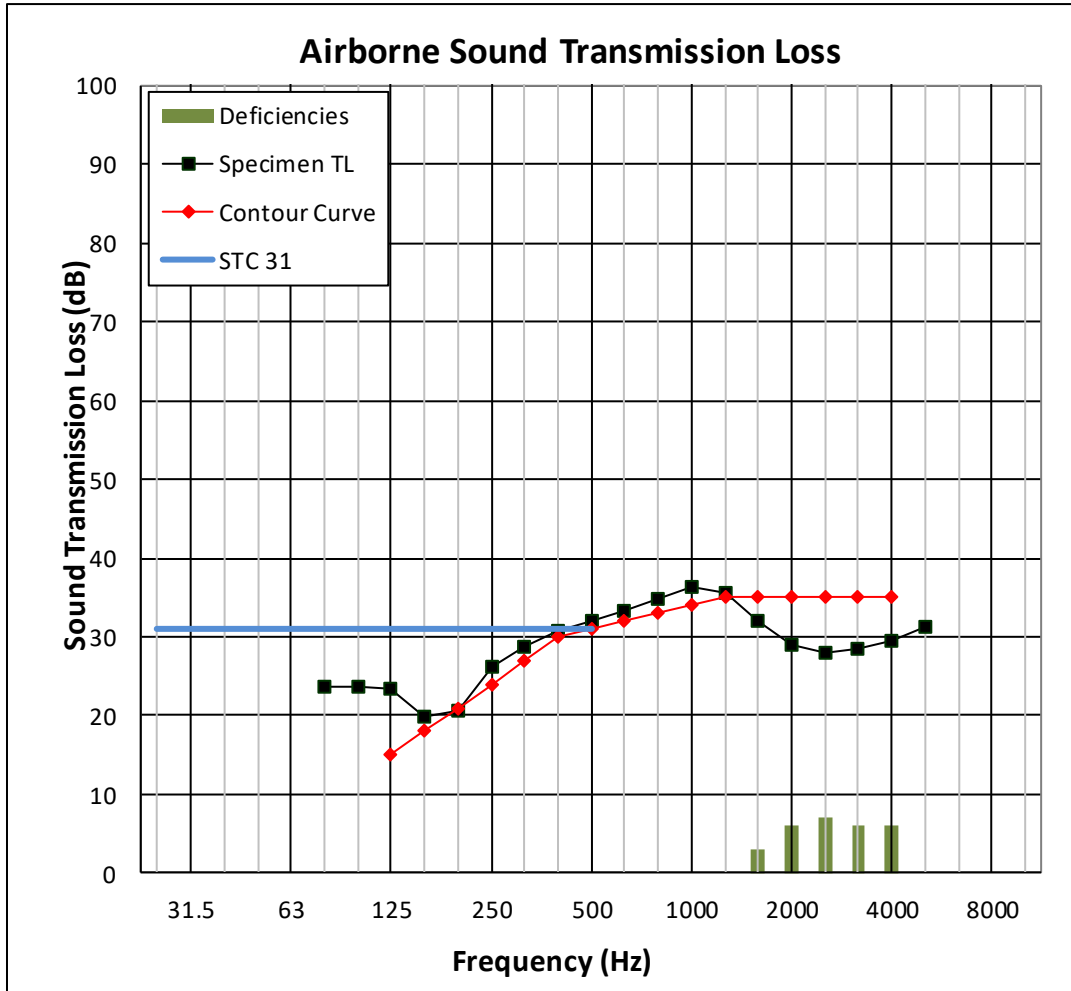
### K4568.02 GRAPH

FREQ (Hz)	BACKGROUND SPL (dB)	ABSORPTION (m <sup>2</sup> )	SOURCE SPL (dB)	RECEIVE SPL (dB)	SPECIMEN TL (dB)	95% CONFIDENCE LIMIT	NUMBER OF DEFICIENCIES
80	41.8	5.4	103	79	24	2.08	-
100	38.5	5.4	105	81	24	1.99	-
125	38.1	5.8	105	81	23	1.63	0
160	40.2	5.7	107	86	20	0.97	0
200	37.2	5.5	106	85	21	1.01	0
250	32.3	5.6	102	75	26	0.69	0
315	25.8	6.1	103	73	29	0.39	0
400	22.7	6.3	102	70	31	0.40	0
500	19.6	6.5	102	69	32	0.46	0
630	19.1	6.2	102	68	33	0.31	0
800	16.4	6.3	101	64	35	0.37	0
1000	13.6	6.6	102	64	36	0.43	0
1250	15.3	7.2	101	63	36	0.27	0
1600	15.3	7.5	99	65	32	0.11	3
2000	12.8	8.2	100	69	29	0.27	6
2500	11.2	9.1	101	70	28	0.15	7
3150	12.9	10.5	100	67	29	0.24	6
4000	15.6	13.1	97	63	29	0.21	6
5000	17.0	16.7	98	61	31	0.31	-
<b>STC RATING</b>	31 (Sound Transmission Class)						
<b>DEFICIENCIES</b>	28 (Sum of Deficiencies)						
<b>OITC RATING</b>	28 (Outdoor-Indoor Transmission Class)

<b>SERIES/MODEL</b>	D350 Series
<b>TYPE</b>	Side-hinged double door system
<b>DESCRIPTION</b>	1" IG (5/16" laminated exterior 7/16" air space, 1/4" tempered interior), Glass temperature 75°F
<b>TEST CONDITION</b>	Operable
<b>DATA FILE NO.</b>	K4568.02
<b>STC</b>	31
<b>OITC</b>	28

To obtain the Sound Transmission Class (STC), read the TL of the contour curve at 500 Hz. The sum of the deficiencies below the contour curve must not exceed 32. The maximum deficiency at any one frequency must not exceed 8.

The Outdoor-Indoor Transmission Class (OITC) is calculated by subtracting the logarithmic summation of the TL values from the logarithmic summation of the A-weighted transportation noise spectrum stated in ASTM E1332.

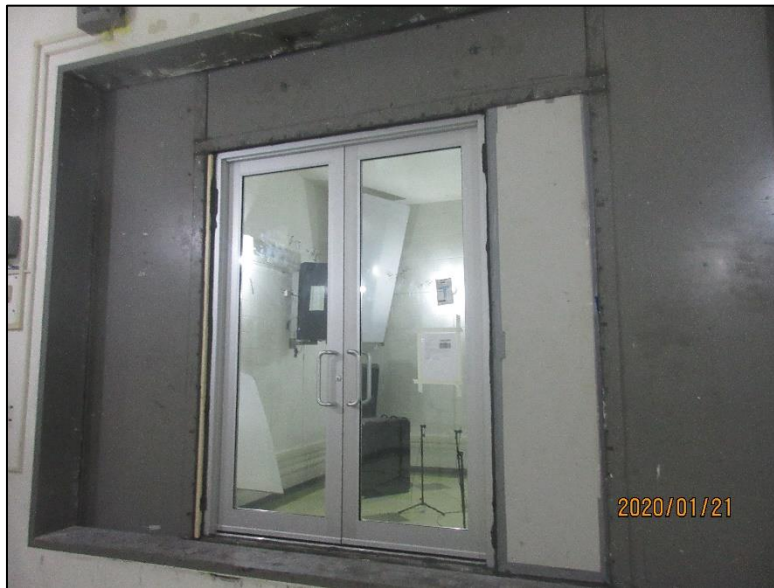
**Photo No. 1**  
**Receive Room View of Installed Test Specimen**

The specimen plug was removed from the filler wall assembly. The specimen was placed on an isolation pad in the test opening. Duct seal was used to seal the perimeter of the specimen to the test opening on both sides. The interior side of the specimen, when installed, was approximately 1/4" from being flush with the receive room side of the filler wall. A stethoscope was used to check for any abnormal air leaks around the test specimen prior to testing. Operable portions of the test specimen, if any, were cycled at least five times prior to testing.

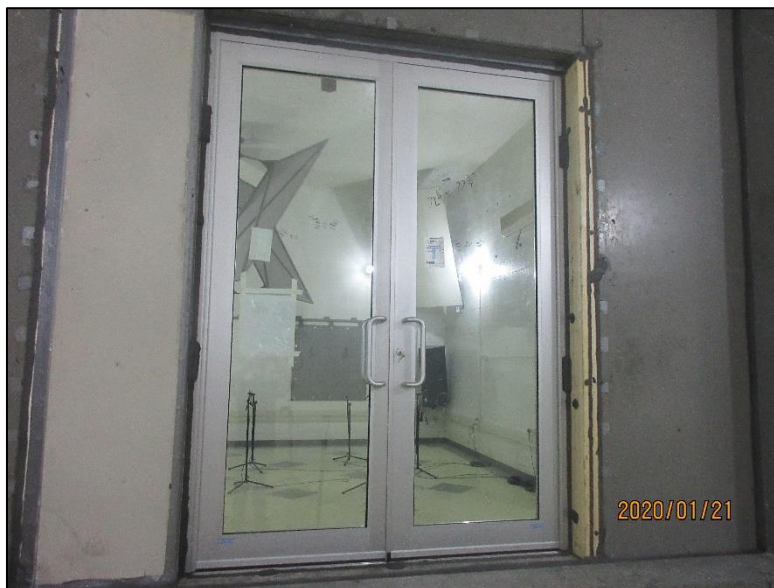
**Photo No. 2**  
**Source Room View of Installed Test Specimen**

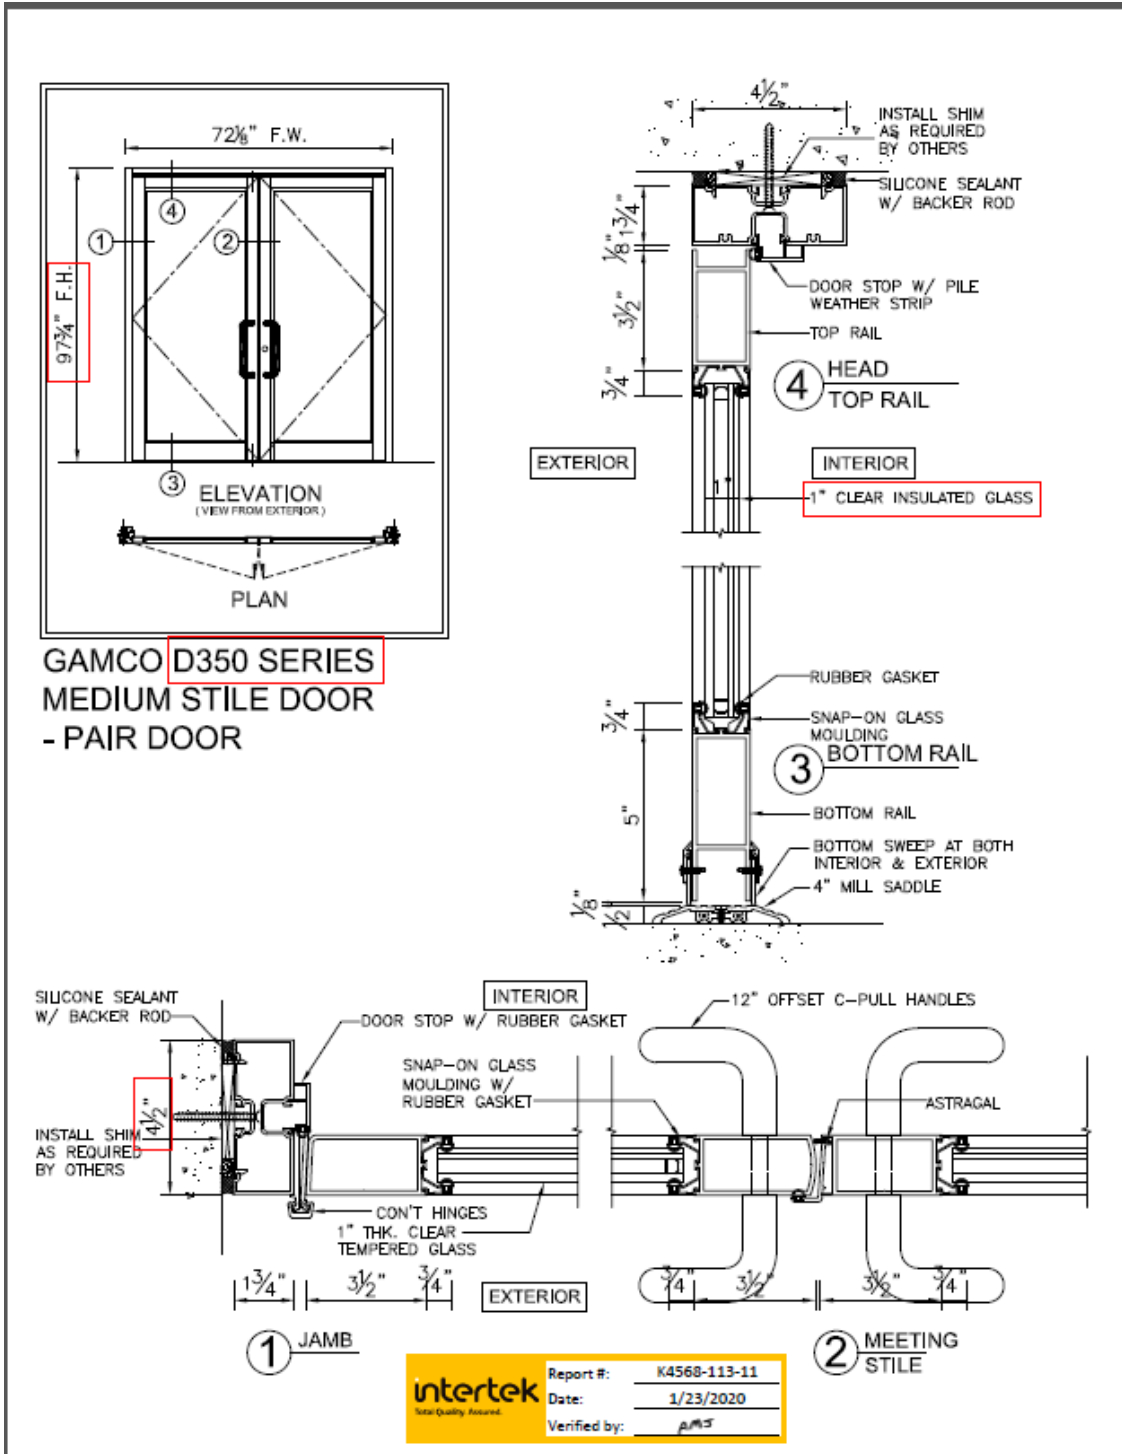
### DRAWING

Photographs are included in Section 11. A drawing of the test specimen is included in Section 12.

FRAME	LEAF (X2)
SIZE	72-1/4" by 97-3/4"	34" by 95-1/4"
THICKNESS	4-1/2"	1-3/4"
CORNERS	Butted	Butted
FASTENERS	Screws	Screws
SEAL METHOD	N/A	N/A
MATERIAL	Aluminum	Aluminum
REINFORCEMENT	N/A	N/A
THERMAL BREAK MATERIAL	N/A	N/A
DAYLIGHT OPENING SIZE	N/A	25-1/4" by 85-1/4"
