TEST REPORT

REPORT No.: 2140.01-106-11

PRODUCT TYPE: Aluminum Fixed Storefront System

SERIES / MODEL: FG450

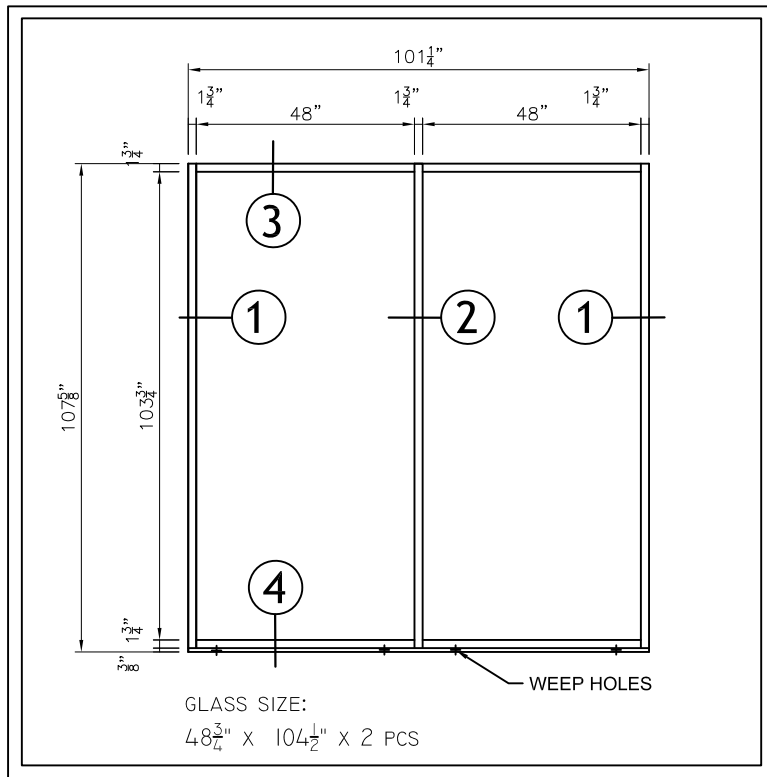
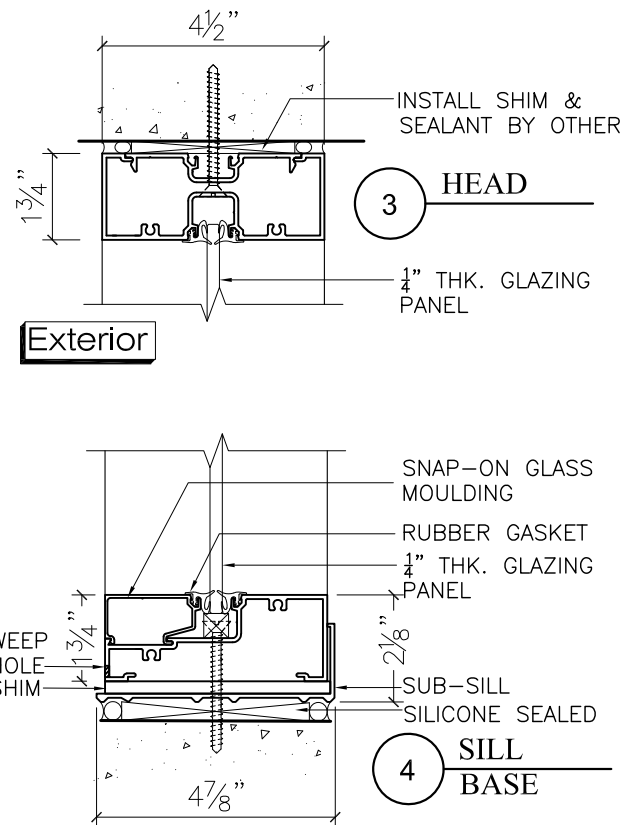
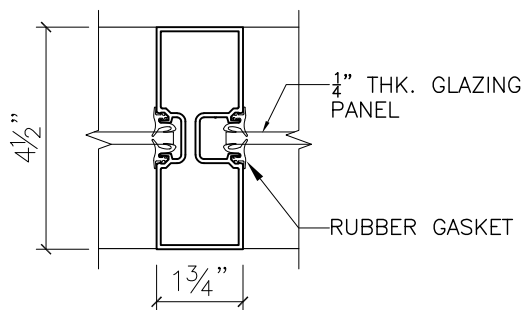
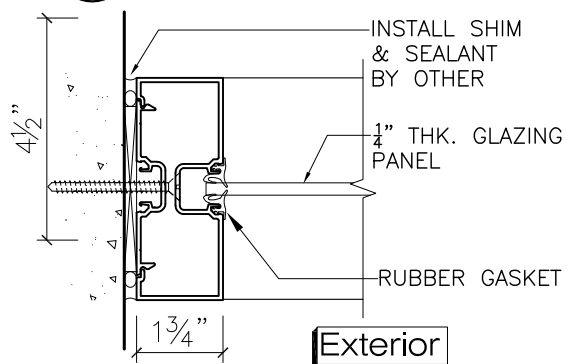
Drawings

FG450 STOREFRONT

1/4" CLR. TM. GLASS
