GAMCO CORPORATION ACOUSTICAL PERFORMANCE TEST REPORT

ASTM E90 SOUND TRANSMISSION LOSS TESTING ON A
FG451T, THERMALLY BROKEN STOREFRONT

K1721.01-113-11-R0

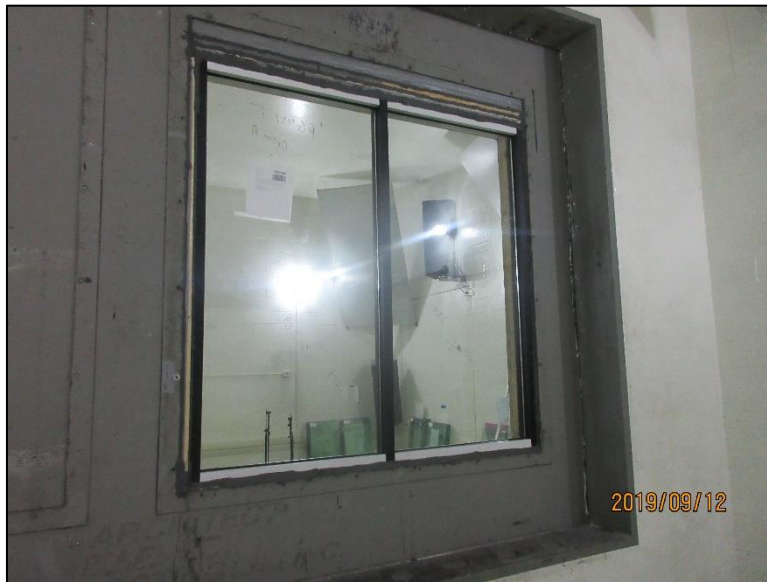
Photo No. 1
Receive Room View of Installed Test Specimen

The specimen plug was removed from the filler wall assembly. The specimen was placed on an isolation pad in the test opening. Duct seal was used to seal the perimeter of the specimen to the test opening on both sides. The interior side of the specimen, when installed, was approximately 1/4" from being flush with the receive room side of the filler wall. A stethoscope was used to check for any abnormal air leaks around the test specimen prior to testing. Operable portions of the test specimen, if any, were cycled at least five times prior to testing.

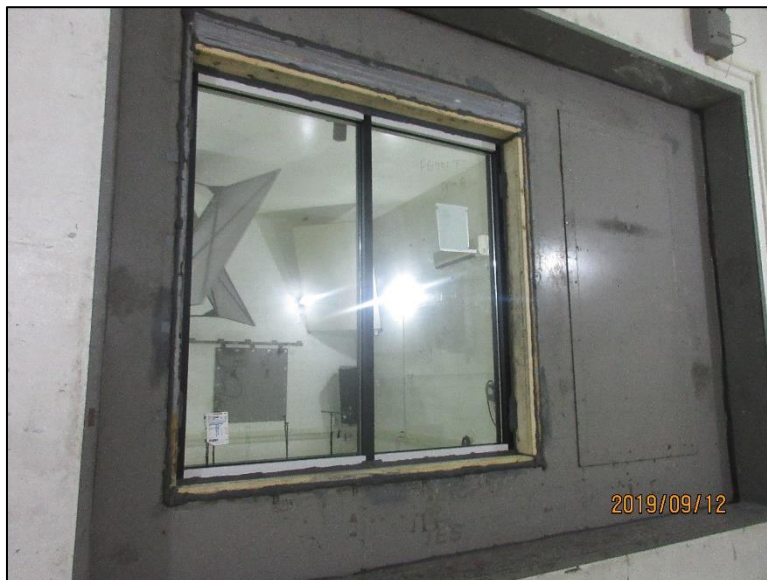
Photo No. 2
Source Room View of Installed Test Specimen

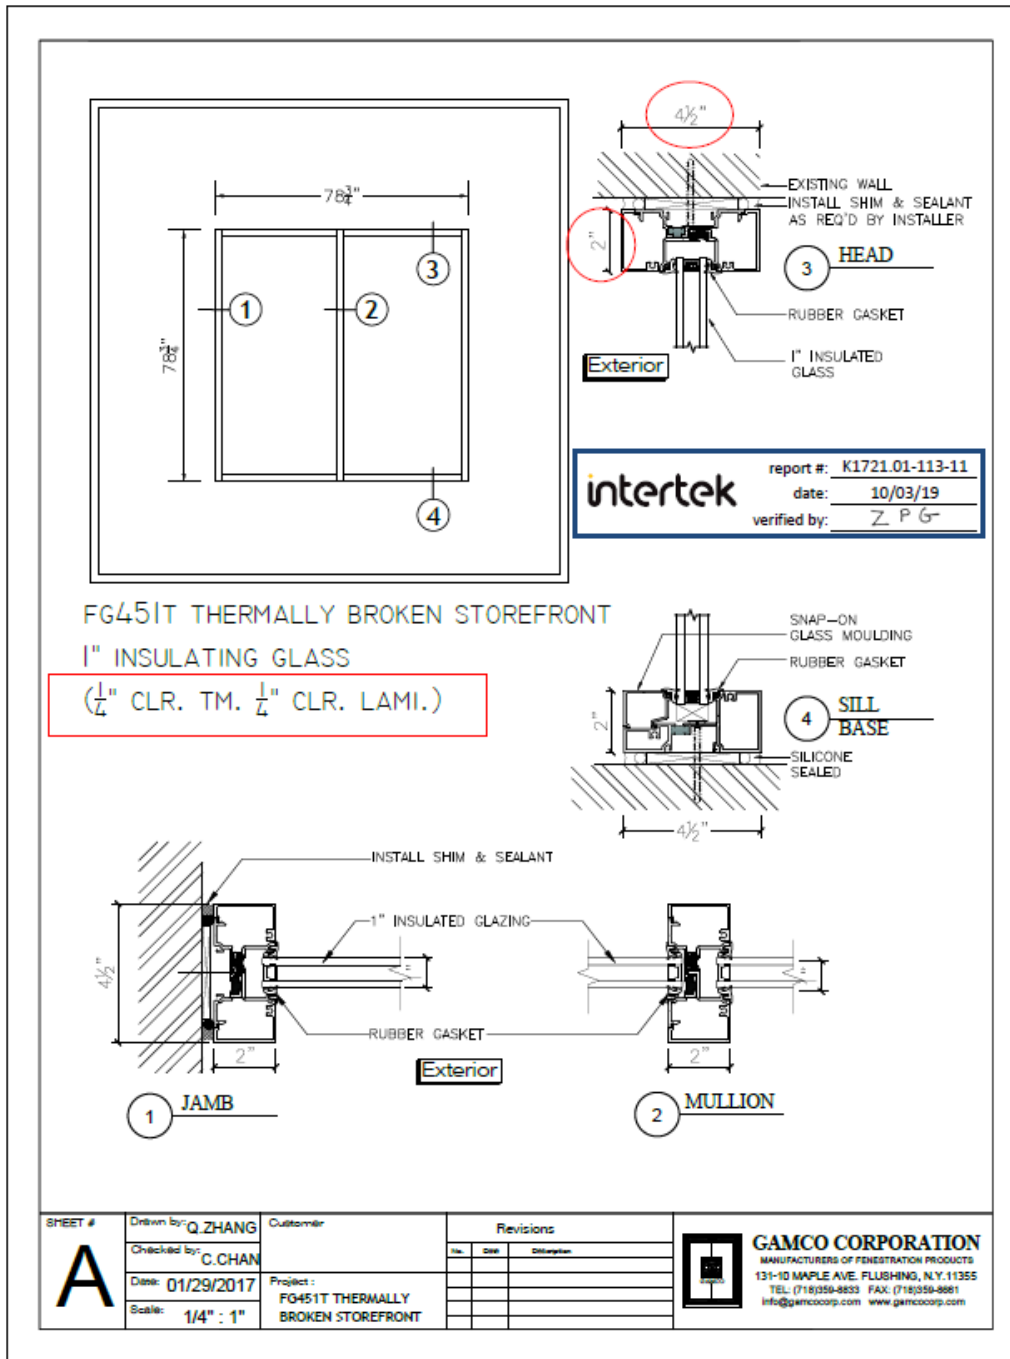
SECTION 12 DRAWING

FRAME	
SIZE	78-3/4" by 78-3/4"
THICKNESS	4-1/2"
CORNERS	Butted
FASTENERS	Screws
SEAL METHOD	Sealant
MATERIAL	Aluminum
REINFORCEMENT	N/A
THERMAL BREAK MATERIAL	Thermally Broken
DAYLIGHT OPENING SIZE (X2)	36" by 74-1/4"

A drawing of the test specimen is included in Section 12.
