GAMCO CORPORATION ACOUSTICAL PERFORMANCE TEST REPORT

ASTM E90 SOUND TRANSMISSION LOSS TESTING ON A FG451, STOREFRONT

K1721.02-113-11-R0

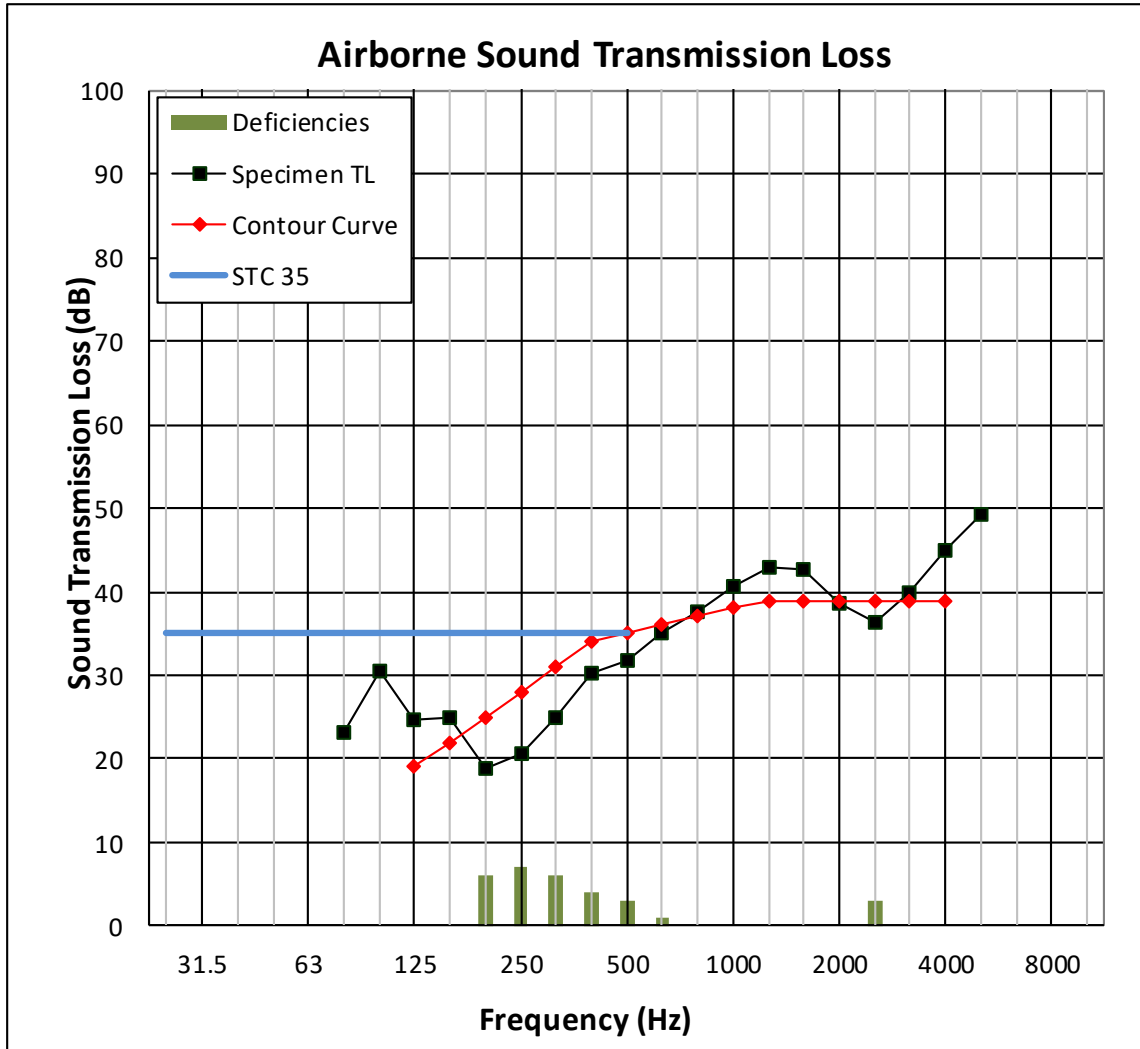
K1721.01B GRAPH

Transmission loss (TL) at each 1/3 octave frequency is the average source room sound pressure level minus the average receive room sound pressure level, plus, 10 times the log of the specimen area divided by the sound absorption of the receive room with the sample in place.

To obtain the Sound Transmission Class (STC), read the TL of the contour curve at 500 Hz. The sum of the deficiencies below the contour curve must not exceed 32. The maximum deficiency at any one frequency must not exceed 8.

The Outdoor-Indoor Transmission Class (OITC) is calculated by subtracting the logarithmic summation of the TL values from the logarithmic summation of the A-weighted transportation noise spectrum stated in ASTM E1332.

| FREQ (Hz) | BACKGROUND SPL (dB) | ABSORPTION (m ²) | SOURCE SPL (dB) | RECEIVE SPL (dB) | SPECIMEN TL (dB) | 95% CONFIDENCE LIMIT | NUMBER OF DEFICIENCIES |
|---|--|---|---|---|---|---|---|
| STC RATING | 35 (Sound Transmission Class) | | | | | | |
| OITC RATING | 28 (Outdoor-Indoor Transmission Class) | | | | | | |

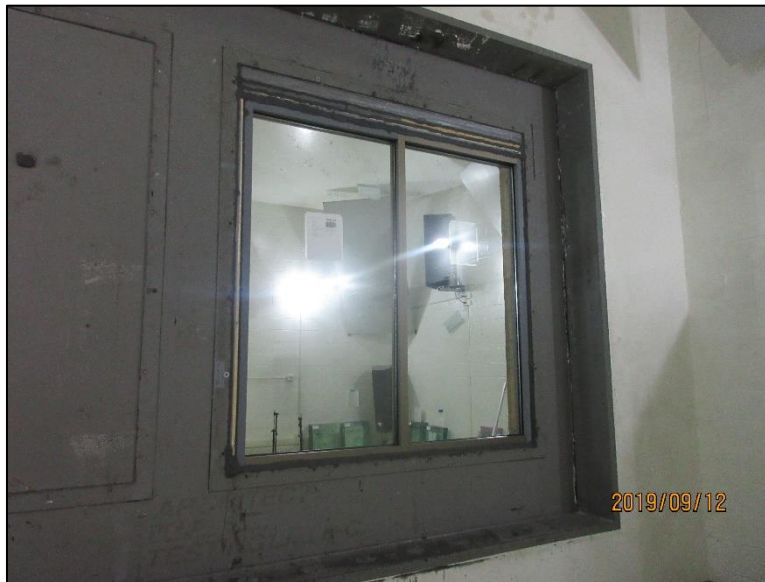
Photo No. 1
Receive Room View of Installed Test Specimen

The specimen plug was removed from the filler wall assembly. The specimen was placed on an isolation pad in the test opening. Duct seal was used to seal the perimeter of the specimen to the test opening on both sides. The interior side of the specimen, when installed, was approximately 1/4" from being flush with the receive room side of the filler wall. A stethoscope was used to check for any abnormal air leaks around the test specimen prior to testing. Operable portions of the test specimen, if any, were cycled at least five times prior to testing.

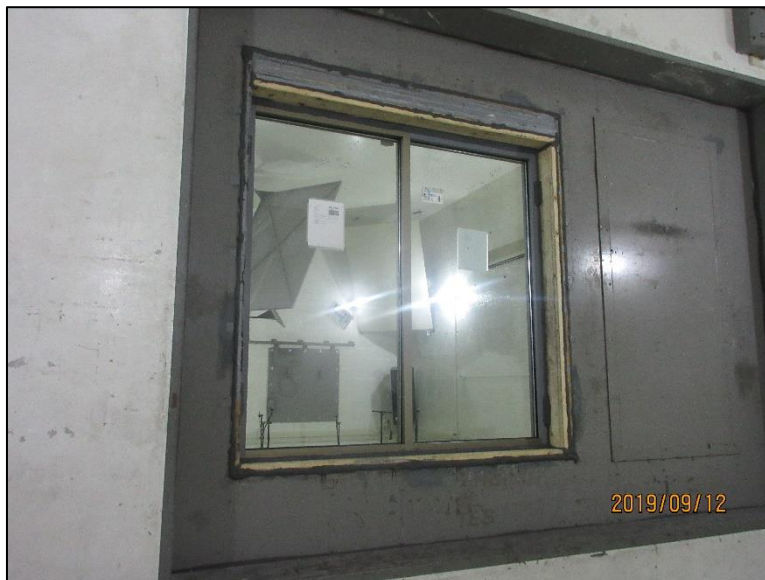
Photo No. 2
Source Room View of Installed Test Specimen

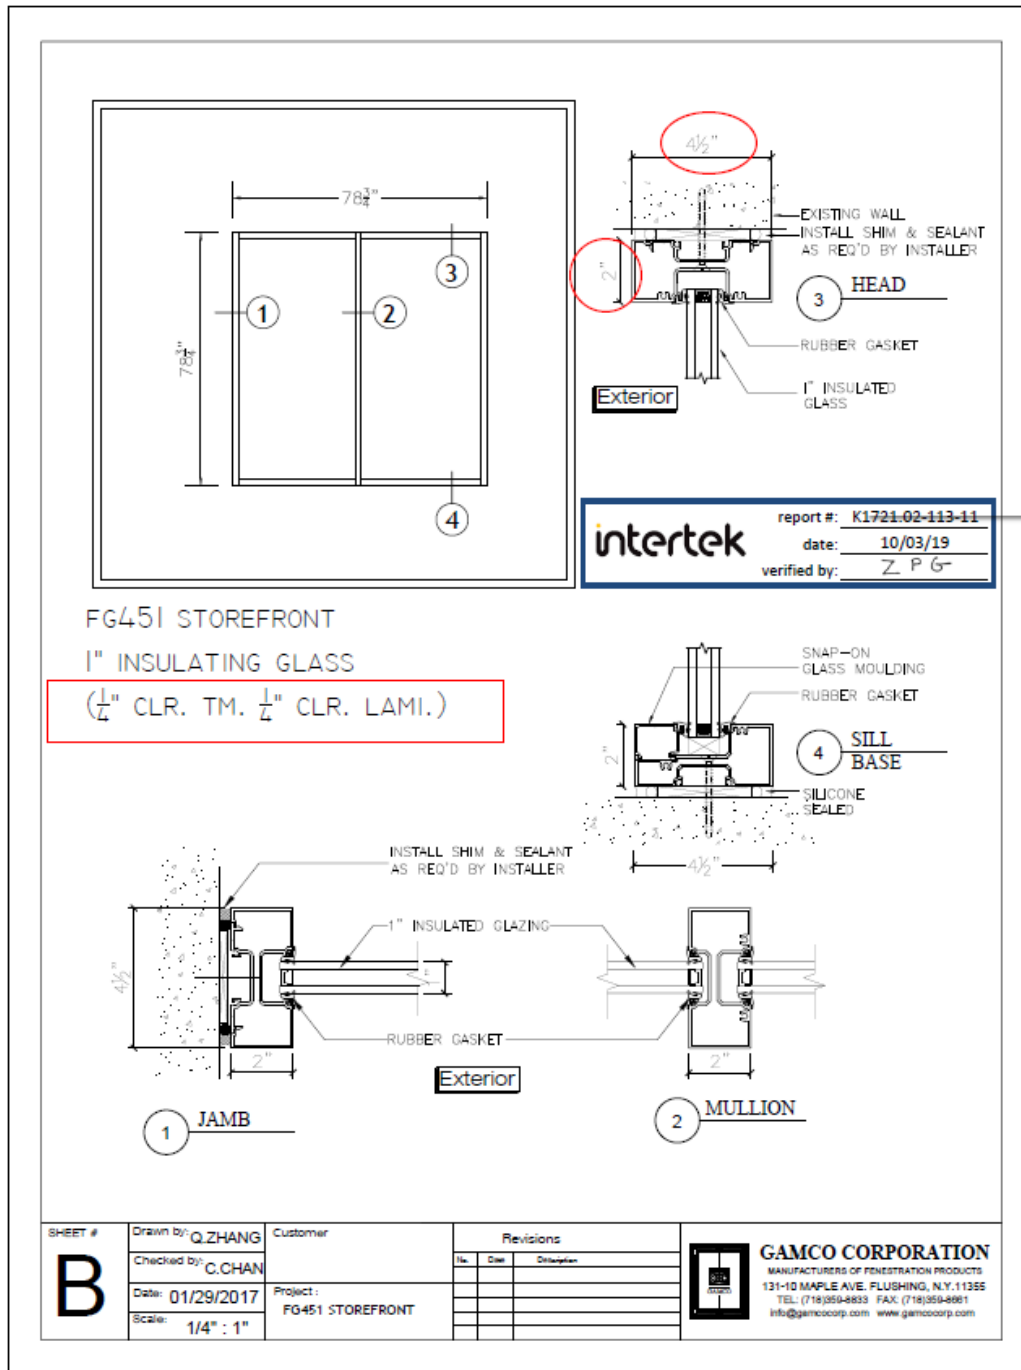
SECTION 12 DRAWING

A drawing of the test specimen is included in Section 12.
